Underwriting Survey Report

May , 2025

Insured: Gyeonggi Green Energy Co., Ltd

Main Business: hydrogen fuel cell power plant

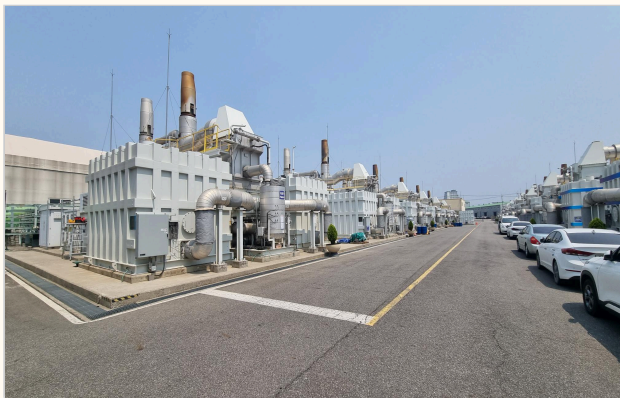
view of site

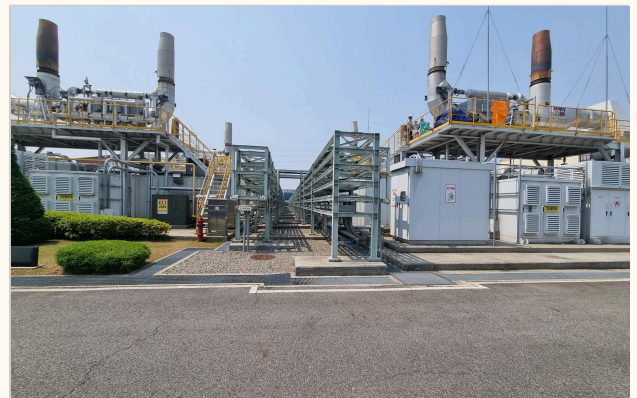
view of site

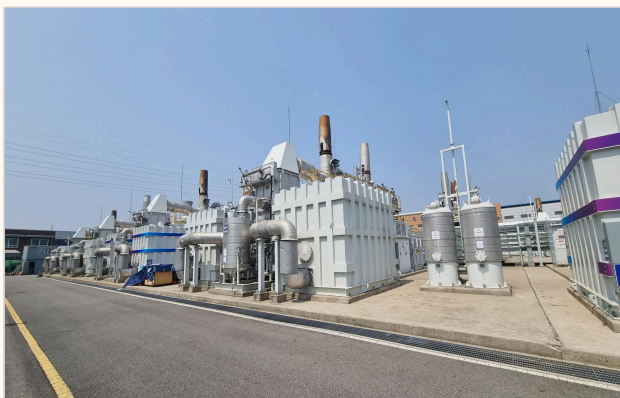
view of module

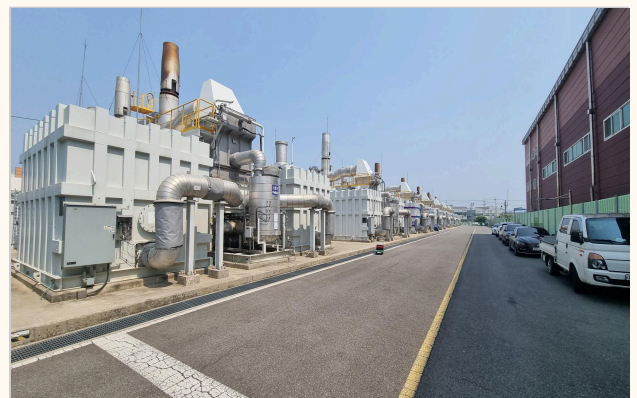
view of module

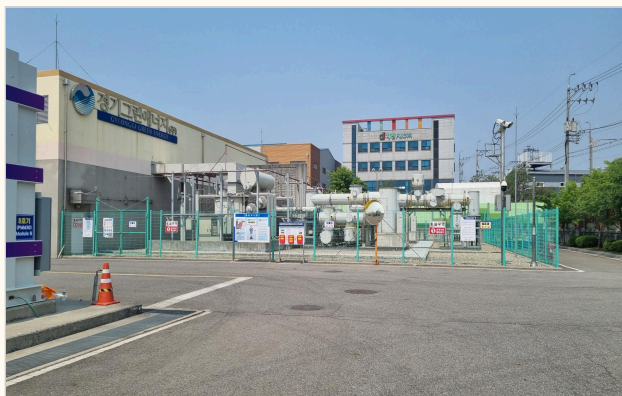
transformers

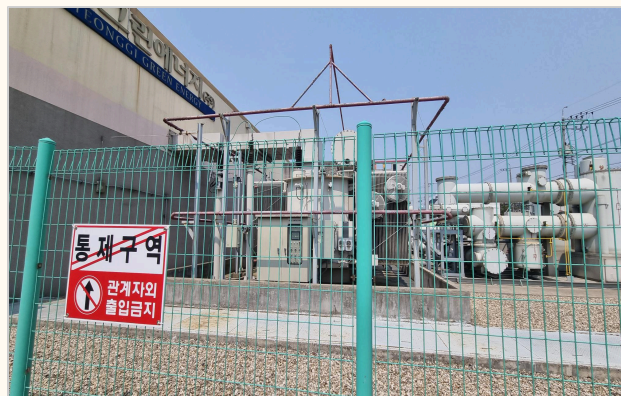
transformer

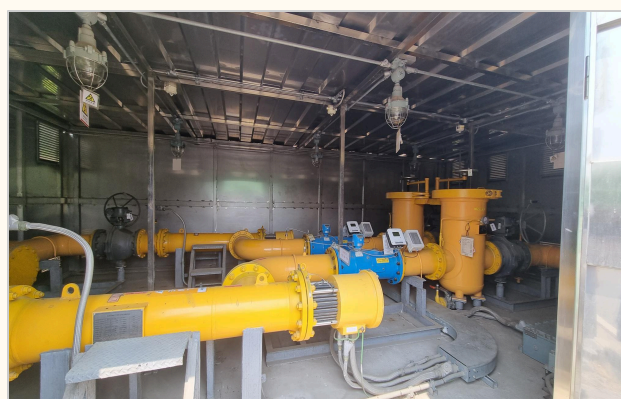
regulator

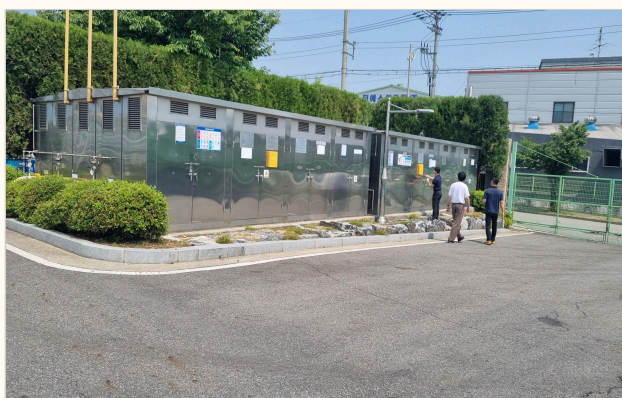
LNG governor chamber

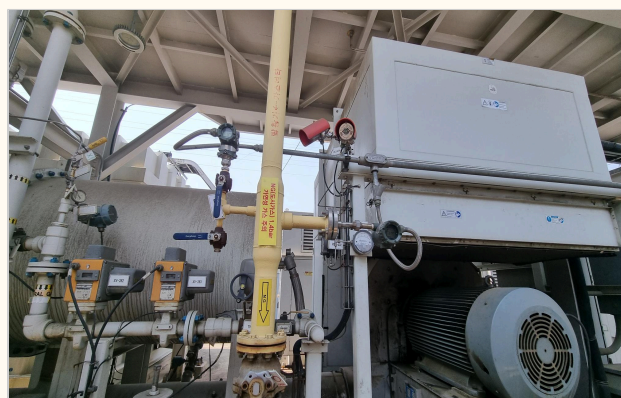
flame detector

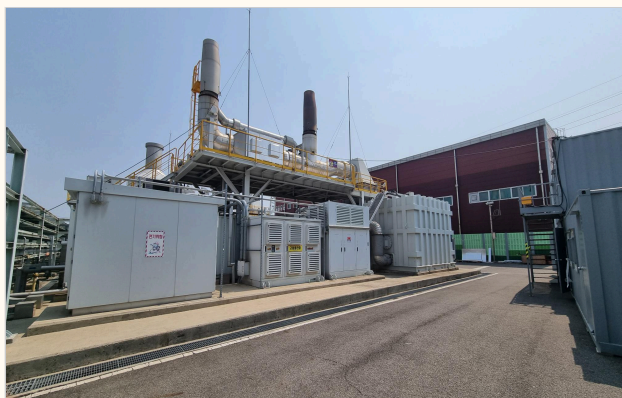
generation modules

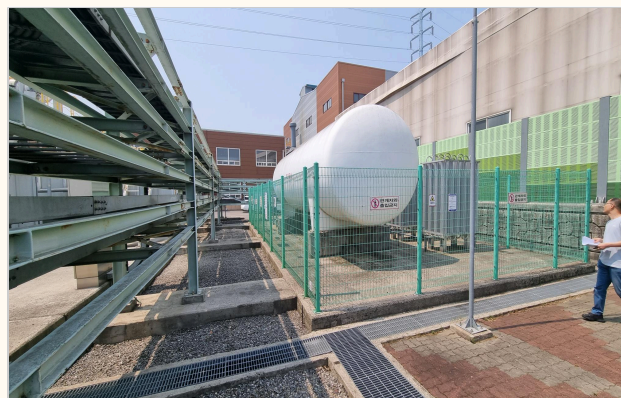
nitrogen tanks

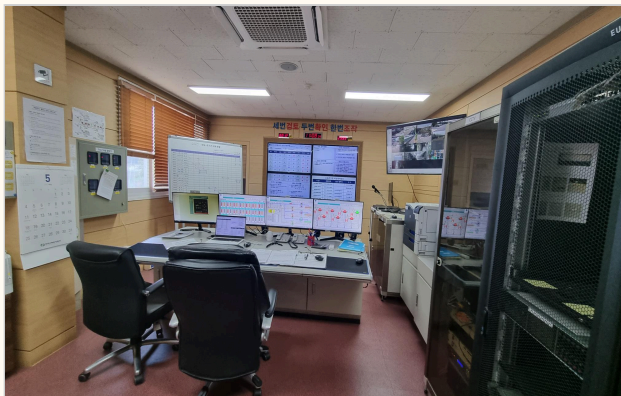
control room

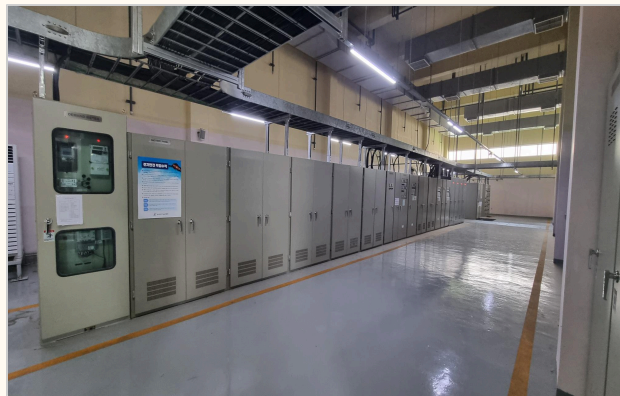
electric room

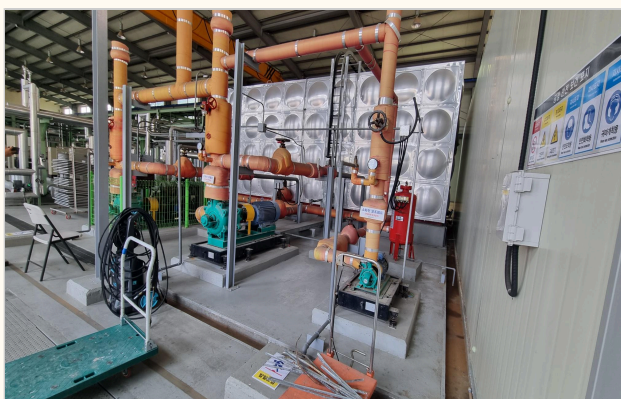
fire pumps

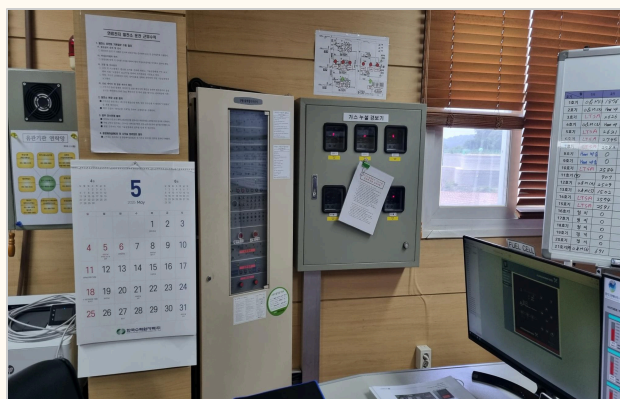
fire alarm receiver

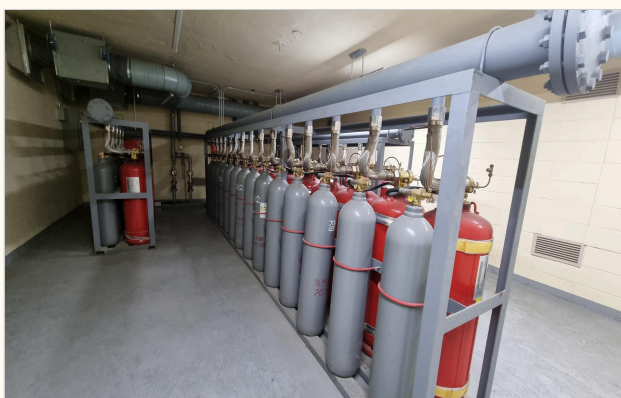
gaseous fire-extinguishing agent bottles

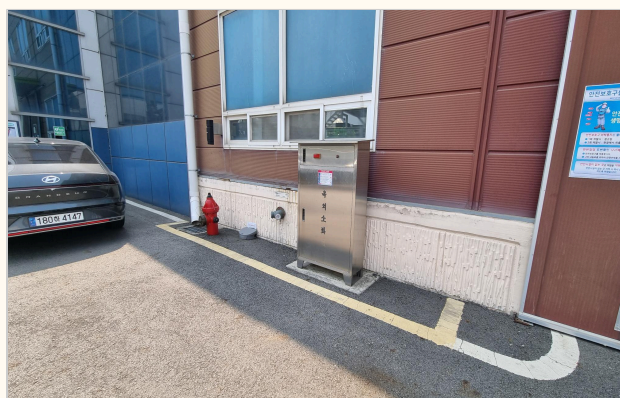
indoor hydrant

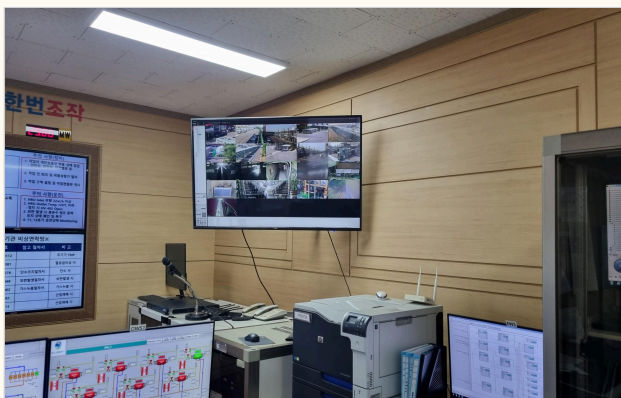
cctv monitor

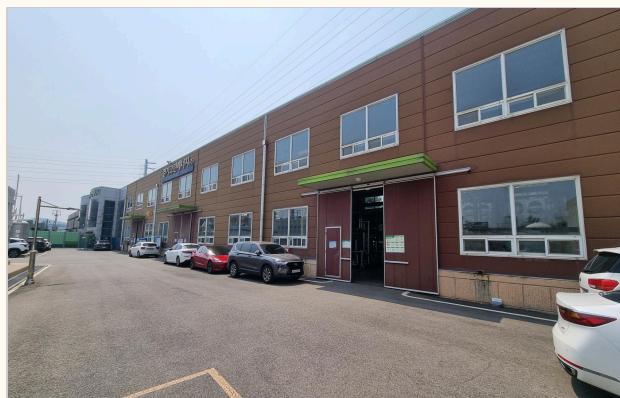
machine room
