Underwriting Survey Report

Property All Risks

May 2025

Gyeonggi Green Energy Co., Ltd.
(Fuel Cell Power Plant)

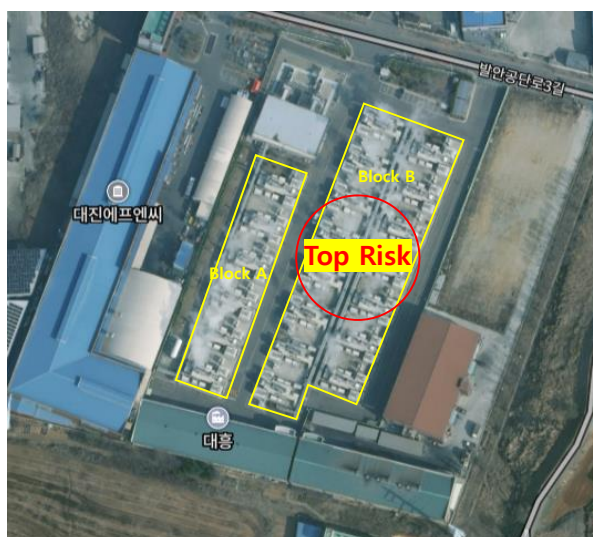
Pic. Top Risk on the satellite Image

PML for property damage may be broken out by a fire accident of the MCFC facility in the middle of operation. Fire could be occurred by NG explosion at the reformer due to poor ignition. It could be damaged to neighboring MCFC facilities considering layout and fire spreading.

Separation between MCFC facilities is 5~15m, and most of the facilities are metal structures, so the MCFCs and adjacent BOPs (Balance Of Plant) will be damaged partially. We assume that total 7 MCFC units and related BOPs are damaged by fire event, and it is up to 30% of property value of GGEY.

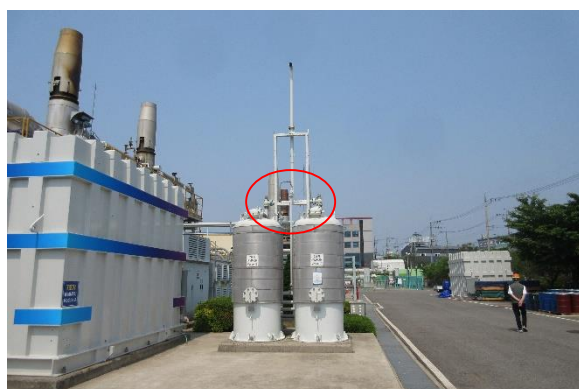
PSVs at the top of desulfurizer

Due to the highly corrosive nature of the electrolyte, various countermeasures are required. MCFC facility has a desulfurizer in each unit to protect stack module for lifetime, and pressure safety valves are equipped to the desulfurizer as well. Rupture disk is also installed at top of the humidifier.

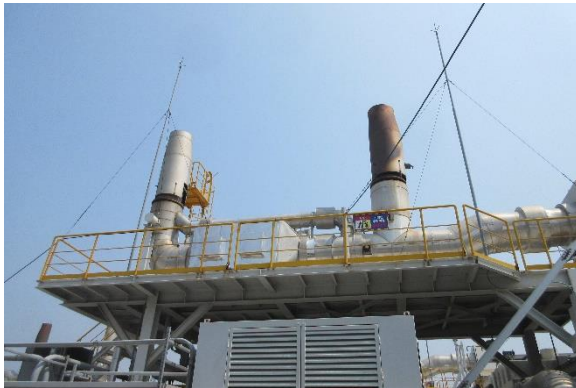
Lightning rod at the top of MCFC unit

Lightning protection systems, which are prepared on the top of the fuel cell facilities, cover the whole area. A fuel cell facility has two lightning rods at the top of the equipment. However momentary power failure could be occurred by lightning.

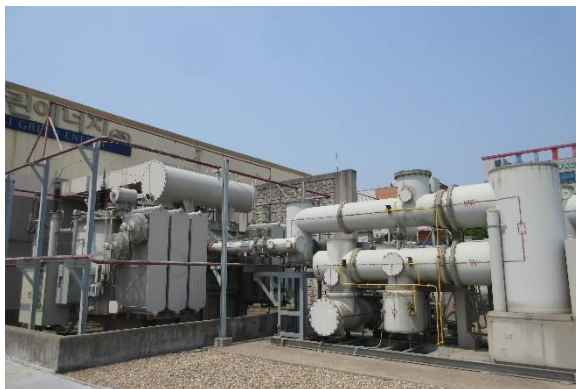
Main TRs & Switch gear

Main substation building is of reinforced concrete structure. There are fire walls between two main transformers. The transformers are in gravel based dike, and protected by water spray system with line type detectors.

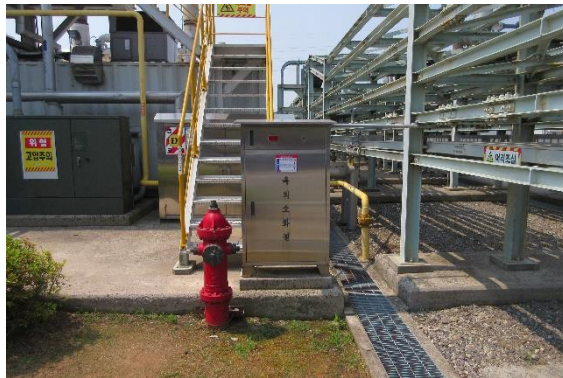
Yard hydrant

Indoor hydrants (4 sets) are installed in main building, and yard hydrants (8 sets) are installed around the site. At the site, PIVs are installed to know the opening and closing of the fire extinguishing water pipe line buried underground. During the survey, there are no obstacles in front of the hydrants and overall maintenance condition is considered to be good.

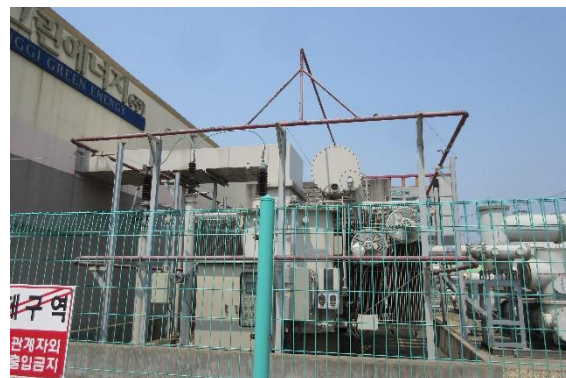
Water spray system for main TR

Main step-up transformers are protected by water spray system (40 heads) and fire wall is installed among the transformers. This water spray system is operated by line type fire detectors.
