Underwriting Survey Report

Property All Risks

May 2025

Gyeonggi Green Energy Co., Ltd.
(Fuel Cell Power Plant)

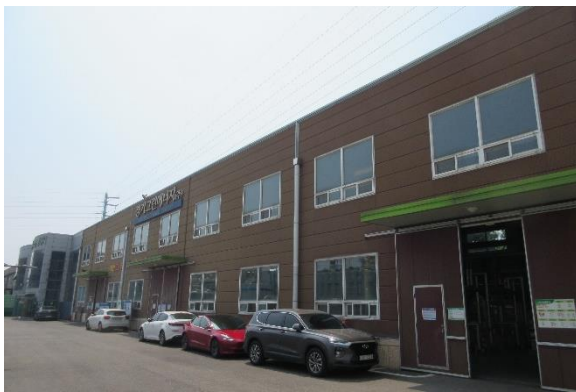
Main building (bldg. No.1)

GGEY has two buildings of the main building and the main substation (See Appendix A. Layout). The main building is made of steel frame structure with sandwich panel wall and roof. Also, the building is mainly divided into utility room and office, and a block wall is prepared between the office & utility room. In case of the main substation, it is of reinforced concrete structure with block wall & slab roof.

Fire proofing is supplied to the steel structural component of the building but details of fire rating was not informed. Also, core insulation of the panel wall & roof is reported to be fire retardant EPS materials.

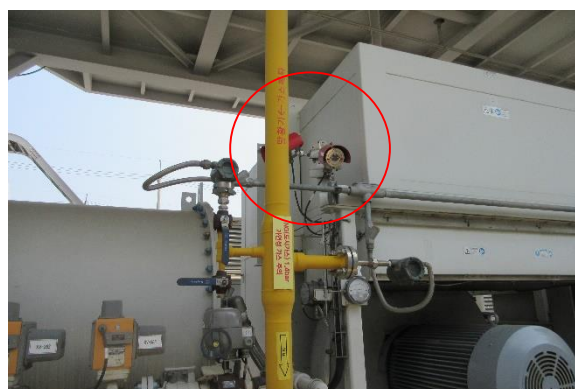
Flame detectors

EMO (Emergency Machine Off) switch is provided to each MCFC unit, and lightning rods are also prepared as well. Around LNG supplying pipe, desulfurizer, reformer and stack modules are designated as explosion proof zone, and flame detectors are provided as well.

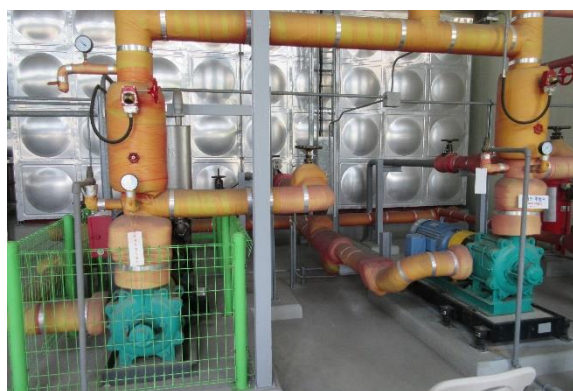
Fire pumps composed of two electrical motor pumps are operated by a pressure drop of pressure tank automatically. Especially, a diesel engine driven fire pump is equipped for stand-by pump of yard hydrant system on an electric power failure.

Location	Fire Water	Fire Pump Specification	Usage
Utility room (1F)	200 tons (common)	Main: 60HP x 70M x 2,000LPM (Motor) St.by: 82HP x 70M x 2,000LPM (Engine) Jockey: 5HP x 70M x 60LPM (Motor)	Yard Hydrant & Water Spray
Office room (1F)	7.8 tons (exclusive)	Main: 15HP x 50M x 390LPM (Motor) Jockey: 3HP x 50M x 60LPM (Motor)	Indoor Hydrant

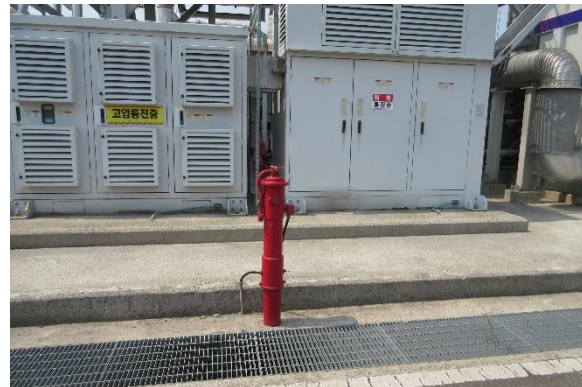
PIV (Post Indicator Valve)

Indoor hydrants (4 sets) are installed in main building, and yard hydrants (8 sets) are installed around the site. At the site, PIVs are installed to know the opening and closing of the fire extinguishing water pipe line buried underground. During the survey, there are no obstacles in front of the hydrants and overall maintenance condition is considered to be good.

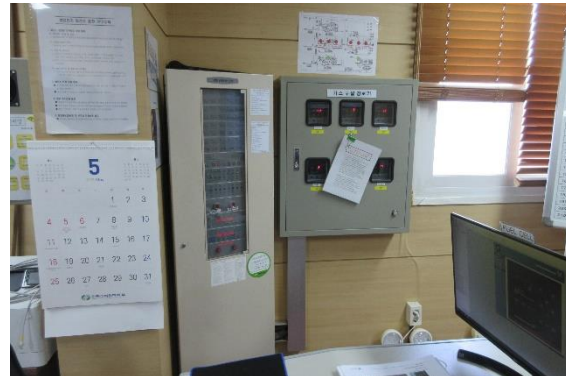
Fire control panel & Gas leak alarm

Smoke and heat detectors are provided in the buildings and line type detectors are installed around the main transformers. P-1 type fire alarm panel is situated at the DCS room where are continuously manned.

Especially, gas detectors and flame detectors are installed at the fuel cell facilities. When a gas leakage is detected, the shutoff valve of the piping is activated in order to prevent explosion and the hydrogen gas is immediately discharged into the atmosphere, and nitrogen purge is carried out at the same time.

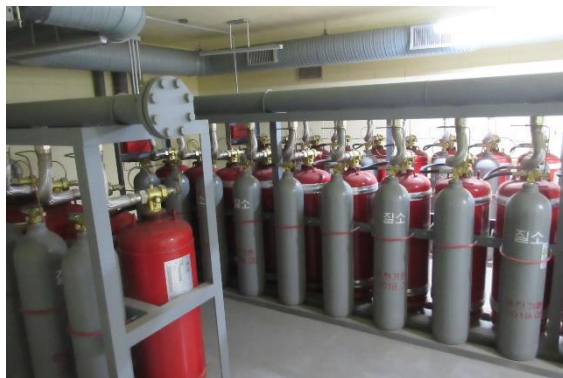
Gas cylinders

Total flooding type gaseous suppression system (HFC-125) is provided with the main substation. The volume of the gas cylinder is 28 bottles x 75kg. It is actuated by fire detection and also, nitrogen injection system is installed for the accident of fuel cell facility. The capacity of the nitrogen gas tank is 30tons.
